U. S. ARMY TRANSPORTATION RESEARCH COMMAND
Fort Eustis, Virginia
April 1964

SWAMP FOX II
REPUBLIC OF PANAMA
VOLUME III. ENGINEERING TEST
USATRECOM Project No. 9R98-003-02

FINAL REPORT

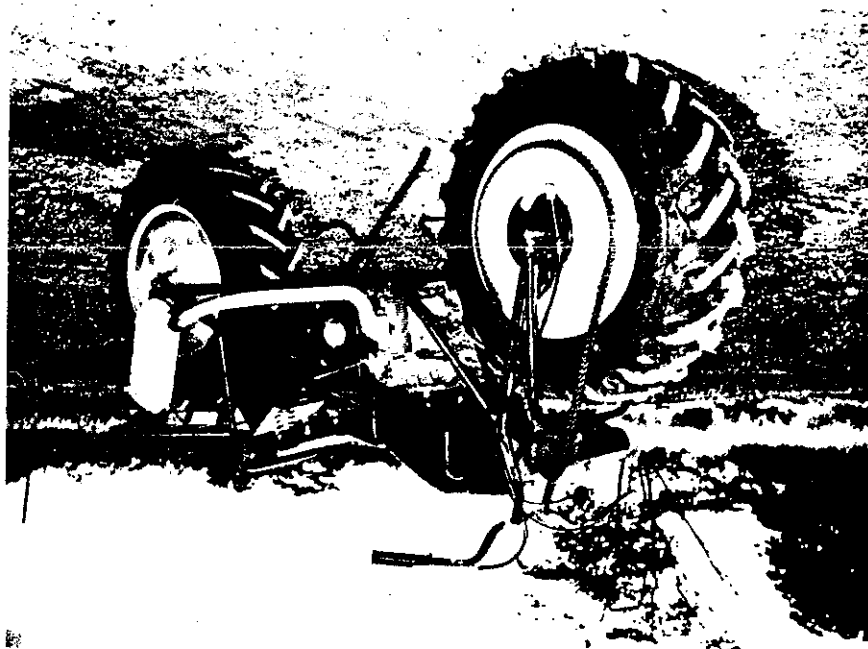
Figure 132. CV-2, Motorcycle, Personnel, 2 x 2. (U. S. Army photograph).

TECHNICAL DATA	
Weight, unloaded (lb.)	184
Payload (lb.)	-
Gross vehicle wt. (lb.)	-
Length	6 ft. 6 in.
Width	2 ft. 4 in.
Height	3 ft. 5 in.
Ground clearance (in.)	14
Angle of approach (deg.)	-
Angle of break (deg.)	-
Angle of departure (deg.)	-
Stability	Handlebar
Maximum speed (MPH)	20
Tire size	6.70 x 15 Chevron
Tire dia. and sect. wt. (in.)	-
Hot soil tire pressure (psi)	2.0
Average ground pressure (psi)	0.85
Engine	9 HP, 1 cylinder, 2 cycle (New Model 12 HP)
Transmission	Manual 3 speed
Suspension	None
Drive	Chain
